# Manhole Inspection Summary

Manhole # S17II\_001MH

Insp Date: **6/8/07 11:18 AM**

**Location** Address: **2351 NORTH-WESTWOOD**

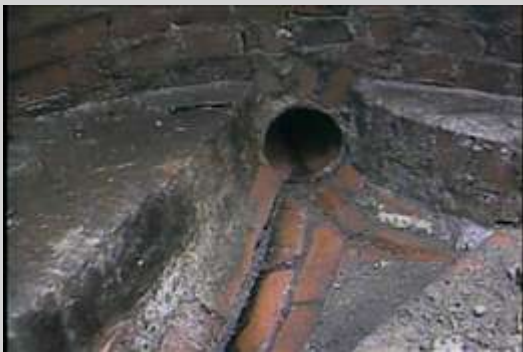
12 O'Clock Outflow

8 in. Circular Gravity Sewer  
Pipe Out @ 12 O'Clock

Pipe Height: **7.2** (in.) Rod and Bar (Angled)  
Pipe Material: **Clay** ☐ Pipe Lined  
Invert Depth: **7.34** (ft.) Flow Characteristics: **Slow**  
Deposits: ☒ None ☐ Mud ☐ Sludge ☐ Debris ☐ Grease  
Silt Depth: (in.) Deposits Extent:  
Infiltration: **None** Pipe Seal Cond: **Sound**

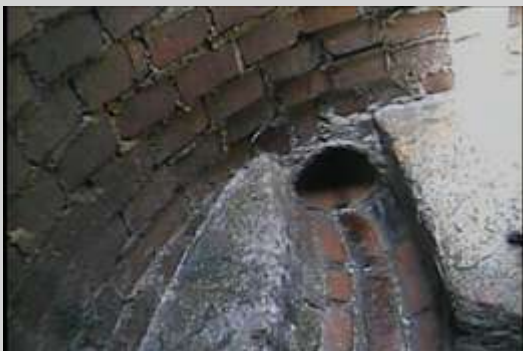
3 O'Clock Inflow

8 in. Circular Gravity Sewer  
Pipe In @ 3 O'Clock

Pipe Height: **8.4** (in.) Rod and Bar (Angled)  
Pipe Material: **Clay** ☐ Pipe Lined  
Invert Depth: **6.76** (ft.) Flow Characteristics: **Slow**  
Deposits: ☒ None ☐ Mud ☐ Sludge ☐ Debris ☐ Grease  
Silt Depth: (in.) Deposits Extent:  
Infiltration: **None** Pipe Seal Cond: **Sound**

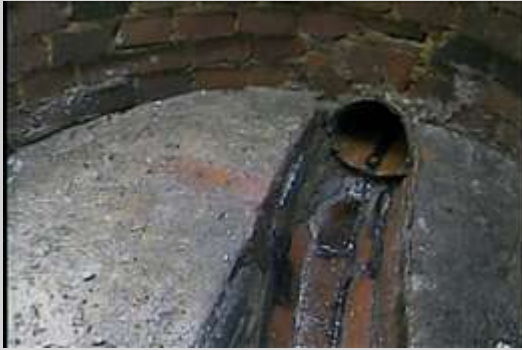
8 O'Clock Inflow

8 in. Circular Gravity Sewer

Pipe In @ 8 O'Clock

Pipe Height: **7.2** (in.) Rod and Bar (Angled)

Infiltration: **None** Pipe Seal Cond: **Sound**
